# **JACK-UP ACCIDENT STATISTICS – YET ANOTHER UPDATE**

R.L Jack and M.J.R. Hoyle  
DNV Noble Denton Marine Services

## **ABSTRACT**

This paper analyses the accident trends from another 8.5 years of operations since the paper “Jack-Up Statistics: A Further Update!” was presented at the 14<sup>th</sup> Jack-Up Platform Conference in September 2013.

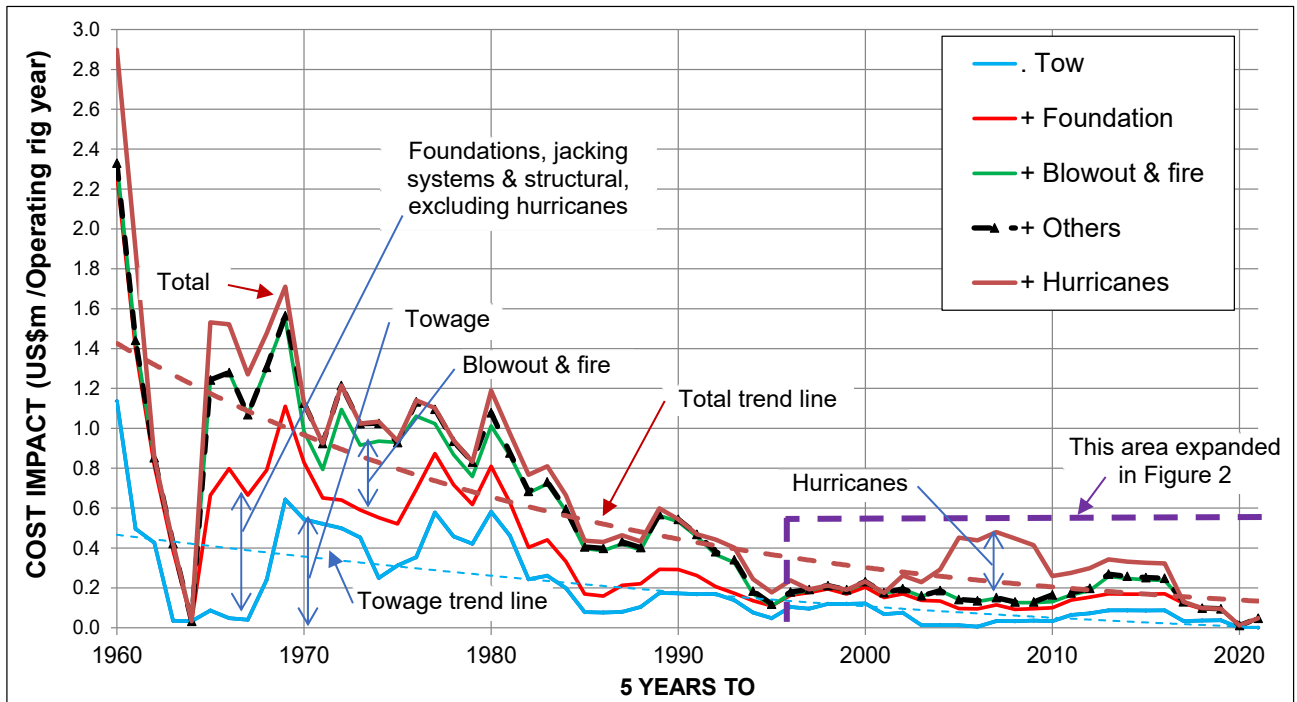
Figure 1 shows the trend of economic impact of jack-up accidents (estimated as the sum of the frequency of each type of accident multiplied by its consequence, expressed in US dollars) over the past 66.5 years. A five-year rolling mean has been used to smooth out the “spikes” caused by the comparatively small working population, especially notable in the early years. It shows the total cost impact divided into five causes in the following order, starting at the bottom:

- 1 Towage incidents
- 2 On location structural, foundation, and jacking system failures (excluding hurricanes)
- 3 Blowouts and fires
- 4 Other (such as slips, falls, lifting, and collision incidents) – generally with more impact on fatalities than cost.
- 5 Hurricane damage when elevated.

**Figure 1: Jack-up cost impact over 61.5 years (5-year rolling means & trend lines)**

Figure 1 shows that the total trend line at the end of 1960 had a cost of \$1.4M per operating rig year. Table 2 show what the (exponential) trend line would have predicted as the loss rate at the end of 2021 using data for the cut-off dates for this and some of the previous papers.

The right-hand column shows that the average annual loss rate was reduced by a factor of 10 over 61 years from \$1.4M to \$0.14M per operating rig year between 1960 and 2021. This corresponds to 3.8% reduction per year compound. The total annual rate reduction deteriorated from 4.1% to 3.8% between 2001 and 2007 and again to 3.3% by the end of 2012, for the reasons given in the 2007 and 2013 papers. The last 8.5 years have shown an improvement to a 3.8% annual reduction rate though the relatively short time spans means that these changes are probably not statistically significant.

Figure 1 shows how the cost impact of blow-outs reduced dramatically from a peak five-year average of \$0.28M per operating rig year in 1983 to zero in 1995 (due apparently to the learning curve of the drilling crews as discussed in the 2001 paper). Figure 2, however, shows a gradual, consistent increase from then through \$0.05M per operating rig year in 2004 to \$0.06M in 2012. There do not seem to be any obvious reasons for this increase; though it may be the drilling of more High Pressure, High Temperature (HPHT) wells, more complex well design or less rigorous checks during well construction. Since 2013 there have been no serious blow-outs on jack-ups reported.

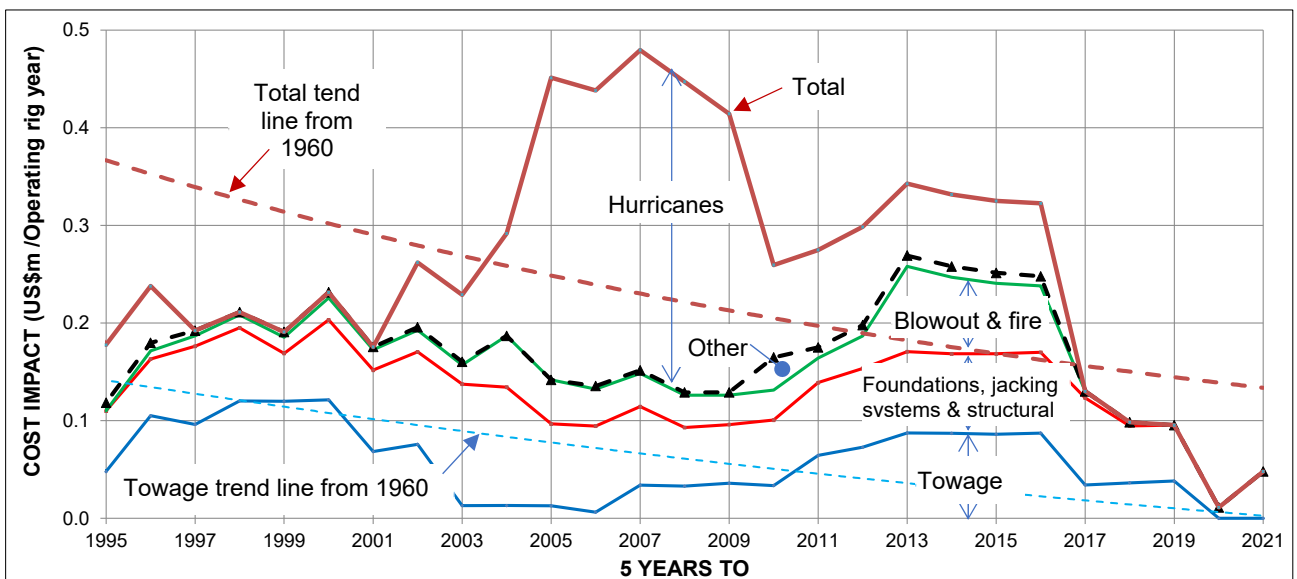
Figure 2 expands the last 26.5 years of Figure 1.

**Figure 2 Jack-up cost impact over 26.5 years (5-year rolling means & overall trend lines)**

Figure 2 shows clearly the significant effect of Gulf of Mexico hurricanes in 2002-2008 and the increase in other risks between 2010 and 2013. The lag caused by using 5-year rolling tends to obscure the exact events. After the loss of the “Rigmar 152” under tow in February 2015, almost all major accidents have been foundation or jacking system failures.

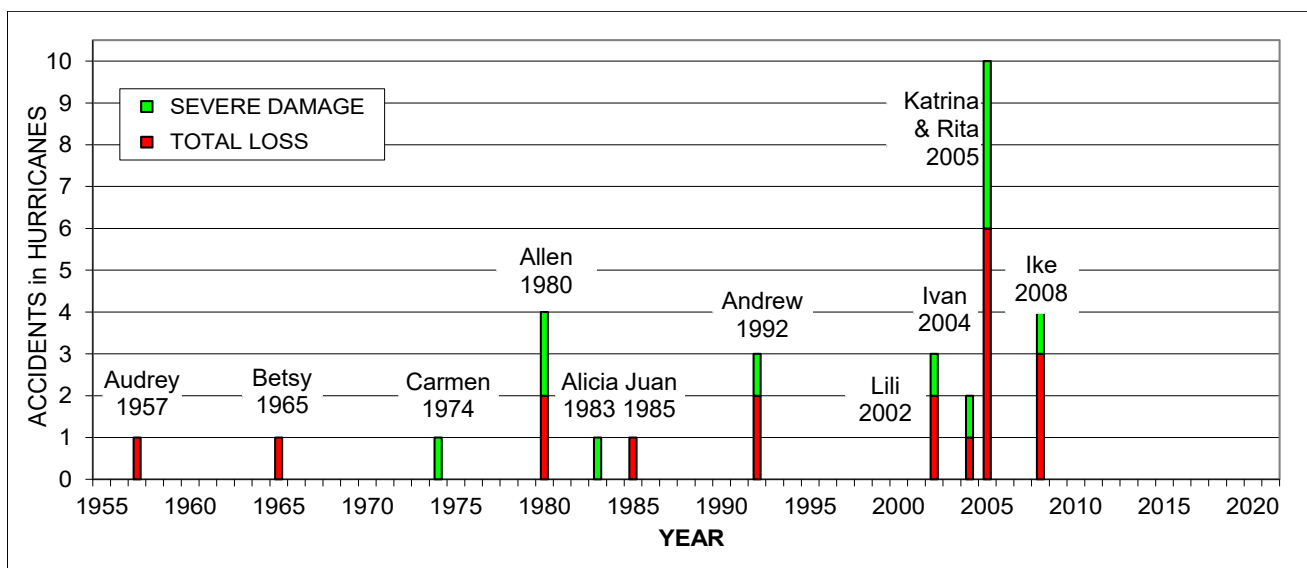
**Figure 3: Jack-up total losses or severe damage in Gulf of Mexico hurricanes**

Figure 3 shows the number of jack-ups in the Gulf of Mexico in any one year that were total losses or had severe damage (over US\$1 million) due to hurricanes. This figure shows the random nature of hurricane damage, due to the randomness and very localised paths of the hurricanes themselves. The increasing number of accidents seems to be mainly a function of the increasing number of jack-ups at risk in vulnerable areas of the Gulf of Mexico, but the 2004-2008 hurricane seasons have also demonstrated a definite trend of increasing storm intensity due to global warming. Of course, with more jack-ups exposed to more severe weather, there is also increased risk of a collision between a “runaway” rig and a drilling or production unit that would otherwise survive, which has caused growing concern amongst operators and regulators.

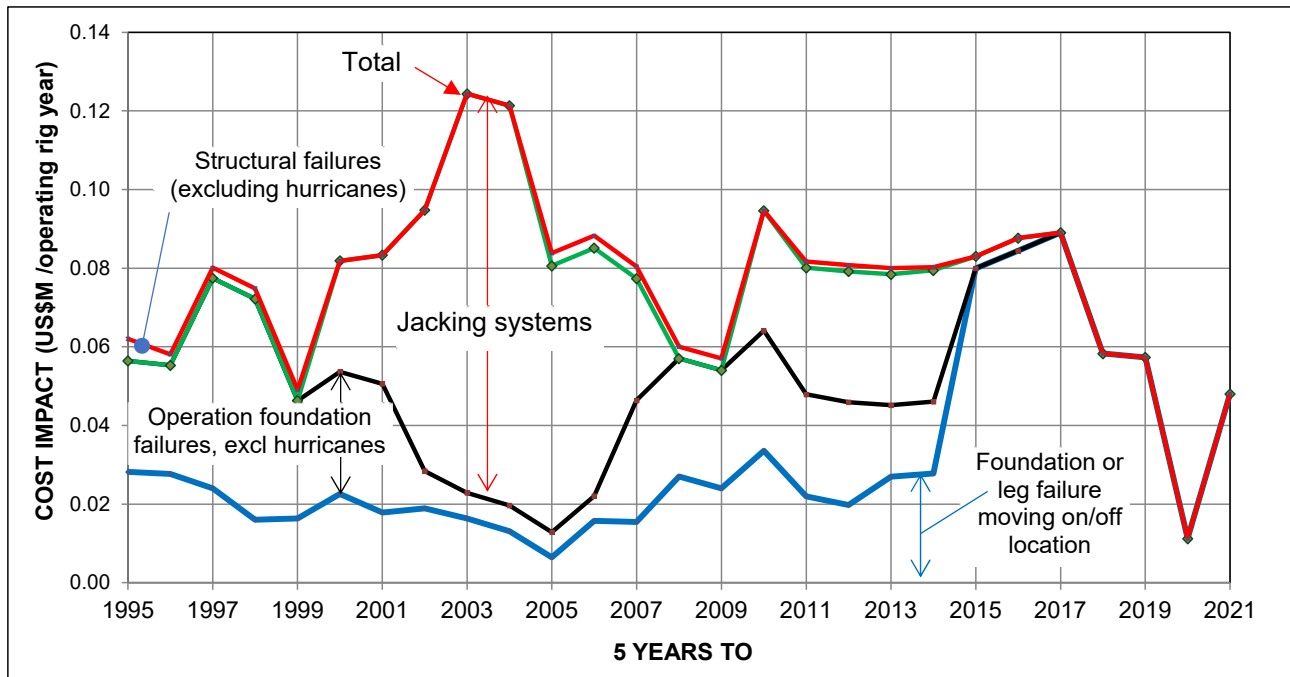
**Figure 5: Jack-up cost impact for structural, foundation and jacking system risks, excluding hurricanes (5-year rolling mean)**

Figure 4 shows the breakdown of the cost impact due to structural, foundation, and jacking system incidents (excluding hurricanes), and the trends since 1995 are shown in Figure 5. There is significant interaction between the four risk categories, especially for foundation failures when moving onto a location. For example, structural failure may be due to a punch-through or a leg sliding into a previous footprint combined with inadequate reserve leg strength.

Figures 4 and 5 also indicate a disappointing pattern in the cost impact due to foundation failures (mainly punch-throughs or sliding into footprints) both when operating and when moving onto location. Having reduced significantly up to 2005, the rate of failure moving on and off location has increased significantly since then and has recently become the main cause of losses. It is often unclear if the rig move team were “ambushed” by the seabed soils (bathymetry, soil strength etc) or were aware and subsequently found that the planned mitigation measures (metocean conditions, airgap or draft, preload amount or sequence) were insufficient or impractical. The use of a minimum airgap is often used as a key mitigation against rapid leg penetration, but may be difficult to achieve when there is a large tidal range or a lot of swell at the location.

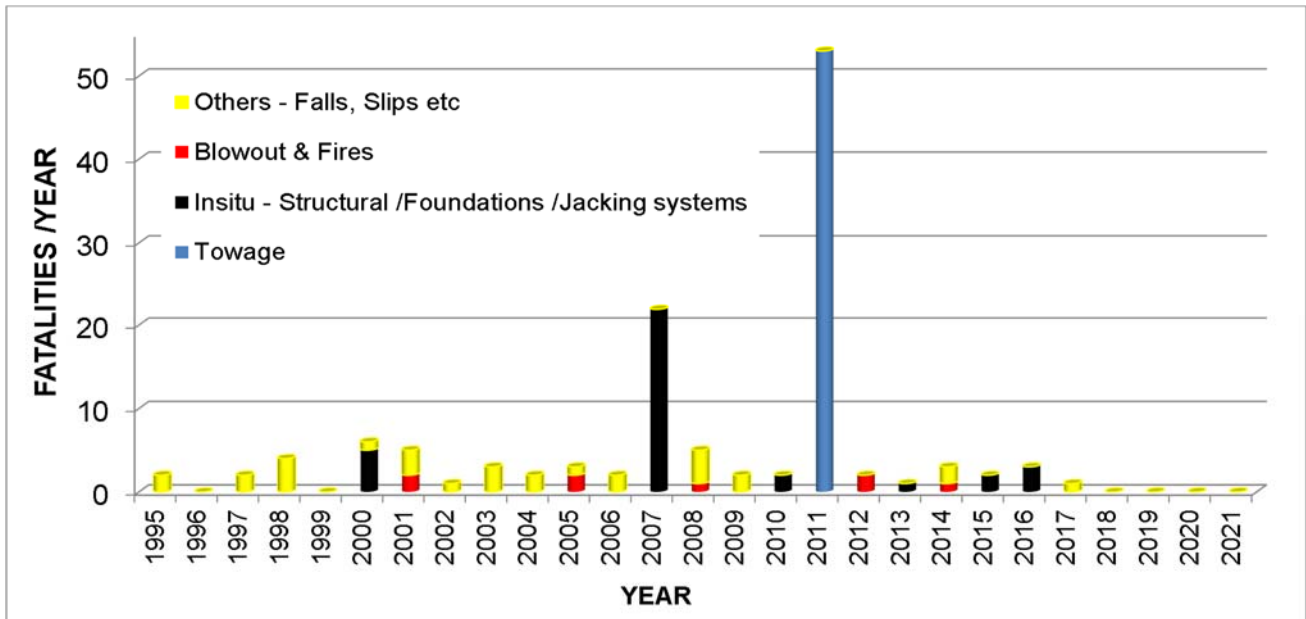
Figure 8: Causes of fatalities on jack-ups over the last 26.5 Years

Figure 8 shows the individual fatalities by cause over the last 26.5 years. This figure shows that the 3 most serious fatal accidents (5 or more deaths) have been due to towage or foundation /jacking system failures and show little pattern.

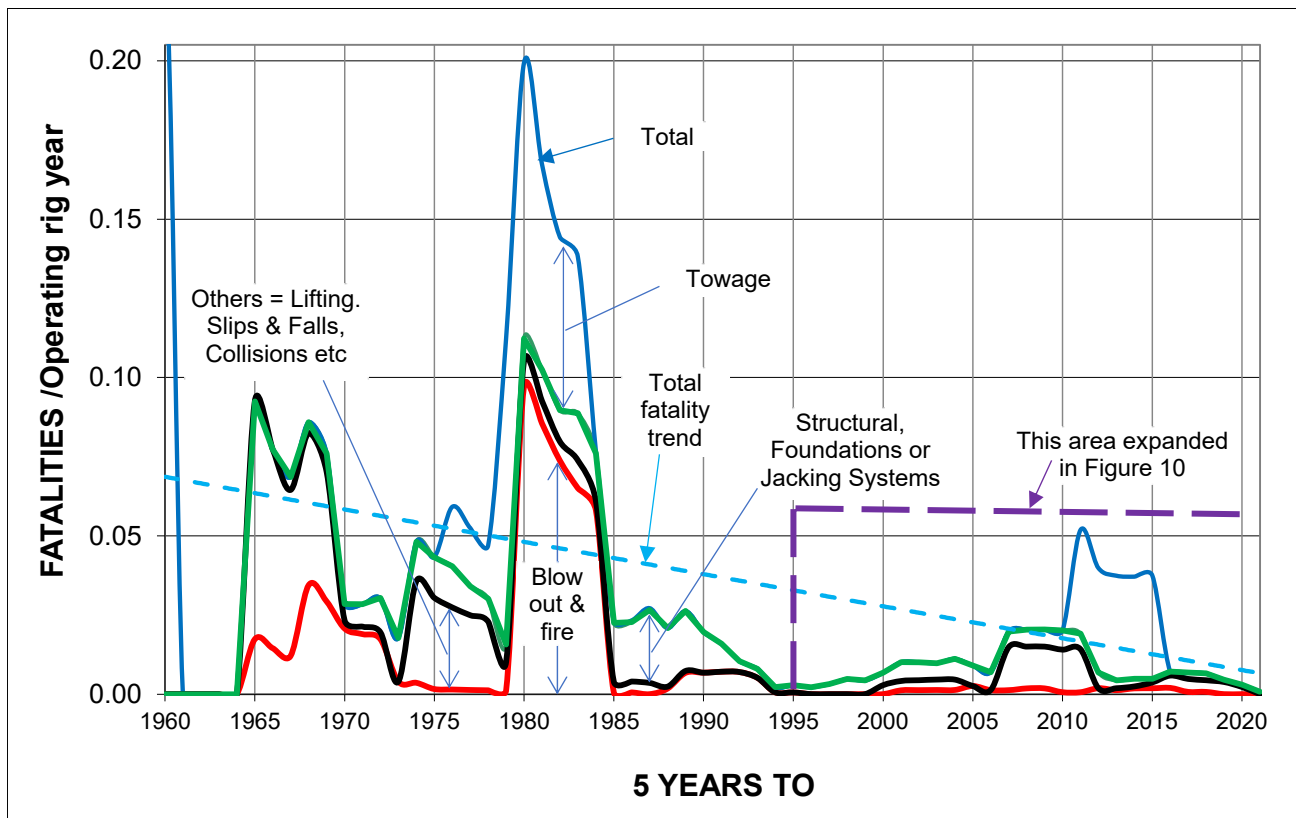
The following Figure 9 shows the 5-year rolling mean fatality rate from 1960 to mid-2021. Figure 10 expands the same data from 1995.

Figure 9: Jack-up fatality rate over 61.5 years (5-year rolling mean)

The total trend line from 1960 in these figures show an encouraging improvement over time. Unfortunately, this is only indicative since an exponential trend line could not be fitted to this data and the logarithmic trend (as shown) and polynomial trend both become negative when projected, which is not reasonable. Even so it shows a reduction by a factor of about 10 (from 0.07 to 0.007 fatalities /operating rig year) over the 61 years which is virtually the same as the reduction in economic risk.

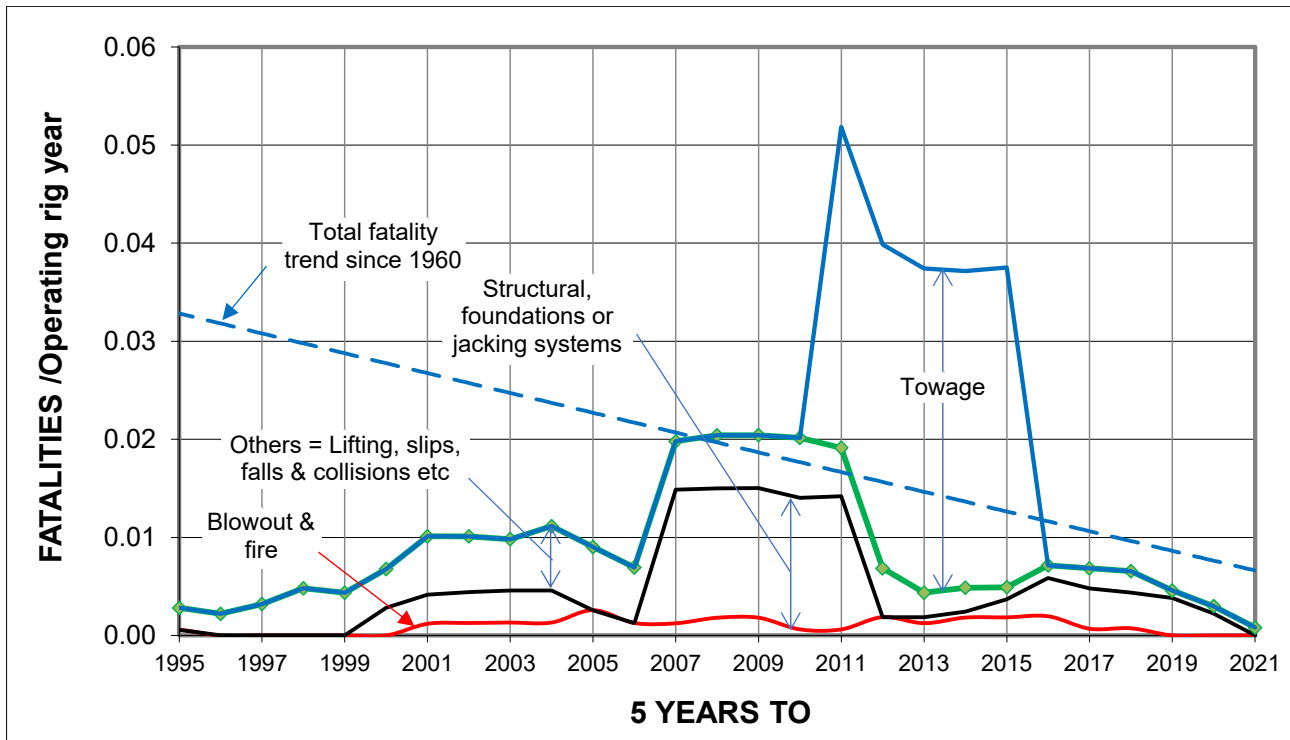
**Figure 10: Jack-up fatality rate over the last 26.5 years (5-year rolling mean)**

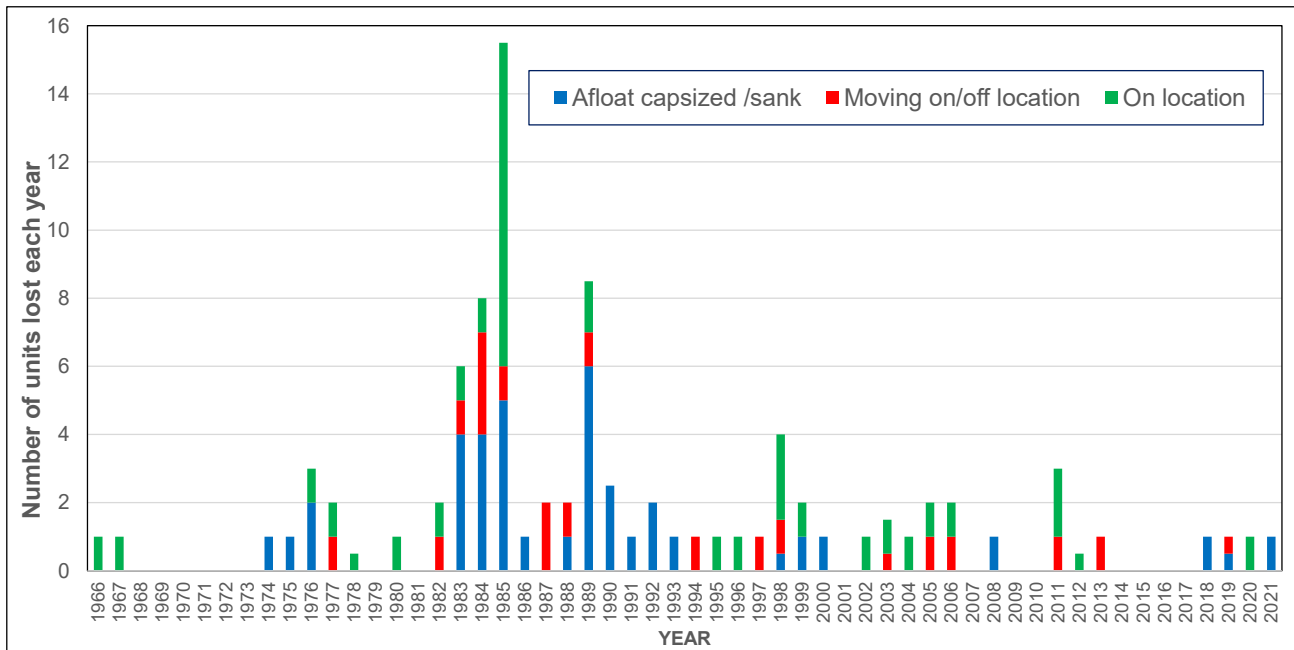
**Figure 11: Losses of liftboats each year**

The following Figure 11 show the number of units lost each year, totalling 90. 4 have capsized or sunk twice and one 3 times. 7 were a result of hurricane JUAN in 1985. Figure 12 shows the number of fatalities each year, totalling 56.

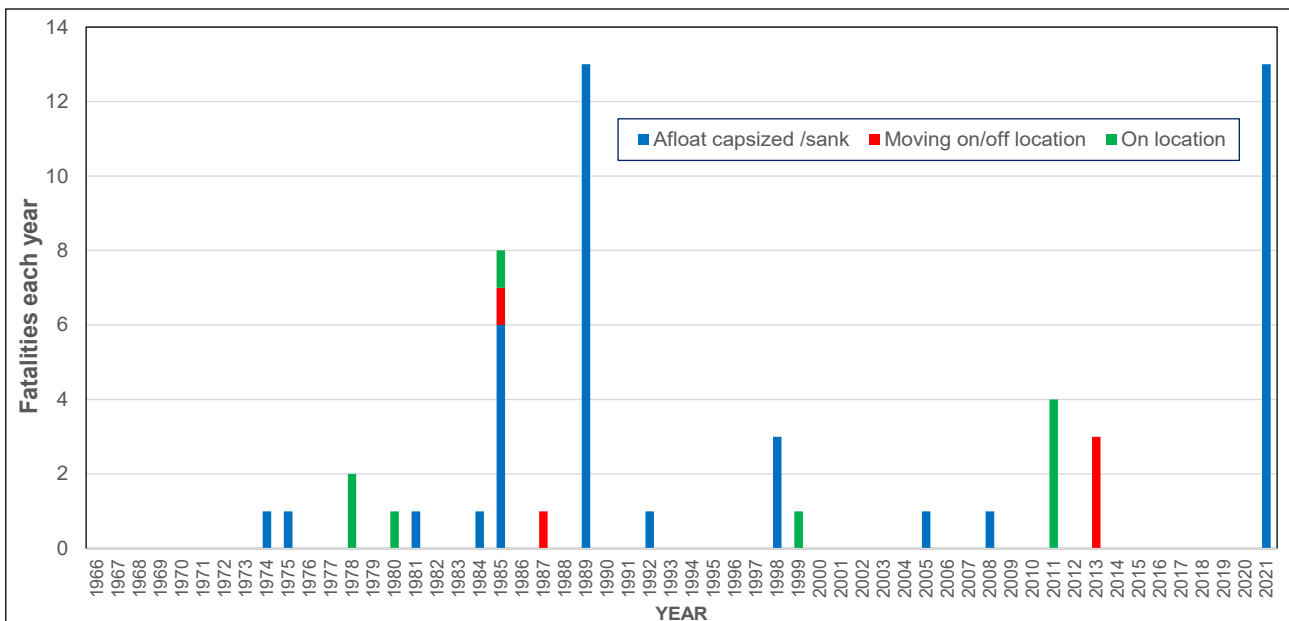
**Figure 12: Fatalities each year on liftboats**
